# Design and Construction of Large-Panel Concrete Structures

## Supplemental Report C "Seismic Tests of Horizontal Joints"

**Seismic Tests  
of Horizontal Joints**

January 1979

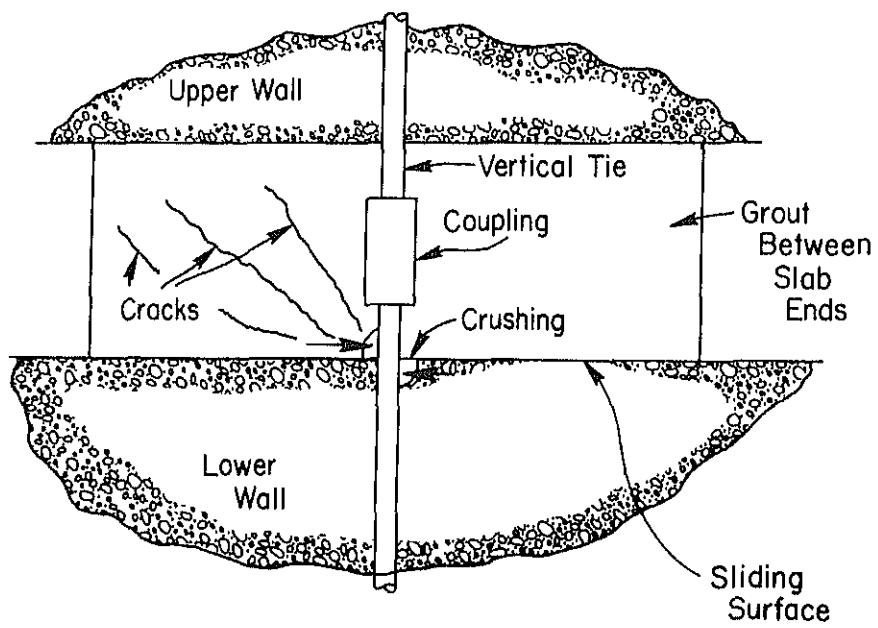
Fig. 18 Grout Cracking

was cracked and split between the slab ends. The latter phenomenon is indicated in the diagram in Fig. 18 and pictorially shown in Fig. 19. The photograph of the specimen disassembled after testing shows the split grout on one side of the vertical tie. The slab part on the left side was cut away to expose the grout damage. Cracking in the lower wall piece in the foreground resulted from disassembly and not from the test.
